# Whitfield County 2020 Local Road Safety Plan

The Engineering Department of Whitfield County has developed a Local Road Safety Plan (LRSP) to identify road hazards and countermeasures for County maintained roads. The report incorporates the “4 Safety E’s”- Engineering, Education, Enforcement, and Emergency Services who are the potential stakeholders in roadway safety and can help plan, implement and evaluate the progress of achieving the safety goals outlined in the LRSP.

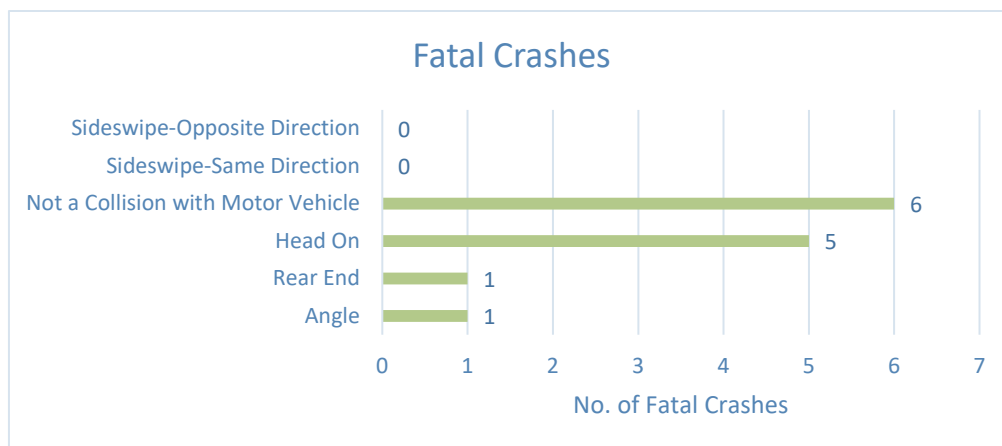
Figure 7: Fatal Crashes by Crash Type

Fatal crashes were studied to identify the hazards that caused the crashes. **Figure 7** shows fatal crashes per crash type.

The majority of fatal accidents on county-maintained roads are either ‘not a collision with a motor vehicle’ or ‘head-on.’ A few fatal crashes involving pedestrians and cyclists at non-intersection locations occurred on county-maintained roads but did not have a pattern making it challenging to target improvements that will make a difference for those crashes. The remaining fatal crashes were dispersed on county-maintained roads. There were three fatal crashes on Reed Road to the south of its intersection with Rauschenberg Road. The overlapping vertical and horizontal curve along with 50 miles per hour speed limit could be a reason for those crashes.

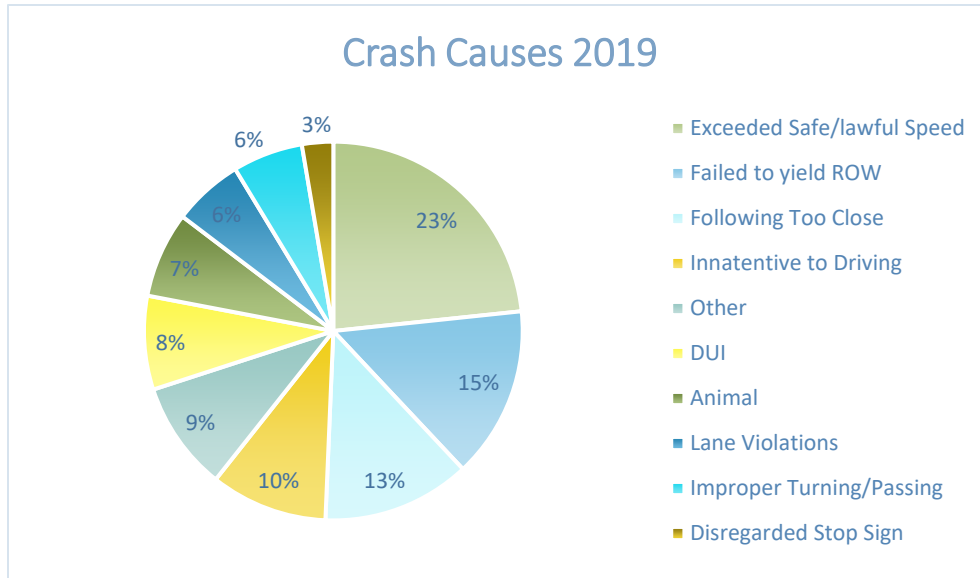
Figure 10: Crash Causes 2019

A reduction in crashes will require safety partners to plan, implement, and evaluate the progress of achieving goals outlined to reduce crashes. The 2019 crash causes for the county-maintained roads are shown in **Figure 10**.

The crash data for the top 10 County roads with the highest crashes in the year 2019 shows that 35 (23%) crashes are due to vehicles exceeding speed limits. Collisions could be reduced by increasing enforcement targeting aggressive driving and changing the driving culture by conducting and supporting public education and outreach activities that elevate the awareness of the dangers of aggressive driving.

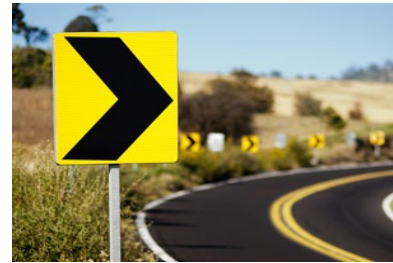
Figure 11: Chevron Sign

Enhanced delineation treatment helps alert drivers in advance about the curve. Safety benefits of installing chevron signs are reduction in nighttime crashes by 25% and reduction in 16% of non-intersection fatal and injury crashes.

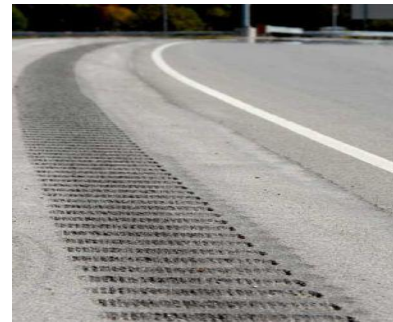
Figure 12: Rumble Strip

Longitudinal rumble strips are raised or milled elements along the shoulder or centerline, which alert the driver through vibration and sound that their vehicle has left the travel lane. Rumble strips are placed underneath the pavement marking, increasing the visibility of markings during nighttime and wet conditions. Centerline rumble strips reduce 44-64% of head-on, sideswipe, and opposite direction fatal and injury crashes.

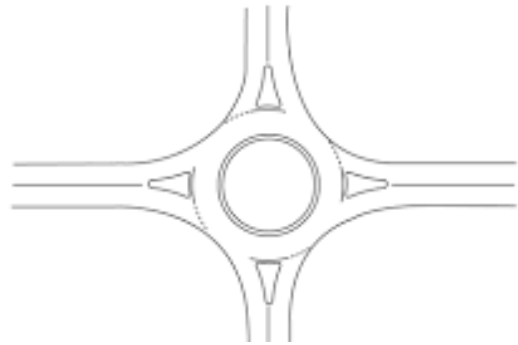
Figure 14: Roundabout

A roundabout can be installed at a signalized or unsignalized intersection as an effective way of managing speed and lowering crashes due to fewer conflict points. If a two-way stop-controlled or a traffic signal is replaced by a roundabout, it can reduce crashes by 82% and 78%, respectively. A roundabout is highly recommended in rural areas due to its substantial safety improvements and operational benefits compared to other intersection controls.

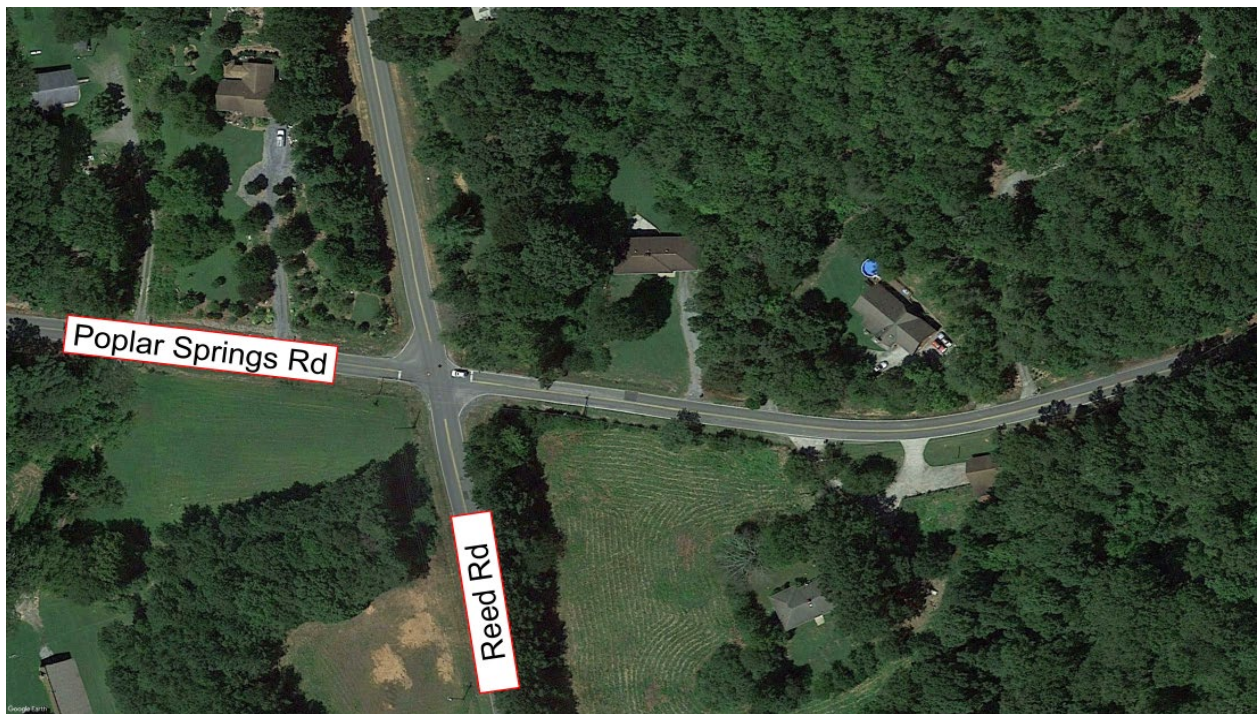
Figure 22: Reed Road and Poplar Springs Road

The intersection at Reed Road and Poplar Springs Road is a conventional minor street stop-controlled intersection. Both Reed Road and Poplar Springs Road are classified as a minor collector with two-lanes. The speed limit on Reed Road is 45 miles per hour, and on Poplar Springs Road is 40 miles per hour. The intersection has a flashing yellow indication for Reed Road approach and a flashing red light for Poplar Springs Road approach. The intersection is located at a downward slope for north and east approaches of the intersection. The intersection is located just after a horizontal curve on Poplar Springs Road in the east. Sight distance from Poplar Springs Road is an issue at this intersection.

There were approximately 27 angle crashes at this intersection. Low-cost improvements include enhancing the delineation of the intersection with warning signs and flashing beacon to alert the drivers. Other enhancements can be changing the intersection to an all-way stop or installing a roundabout. **Figure 22** shows an aerial view of the intersection location.

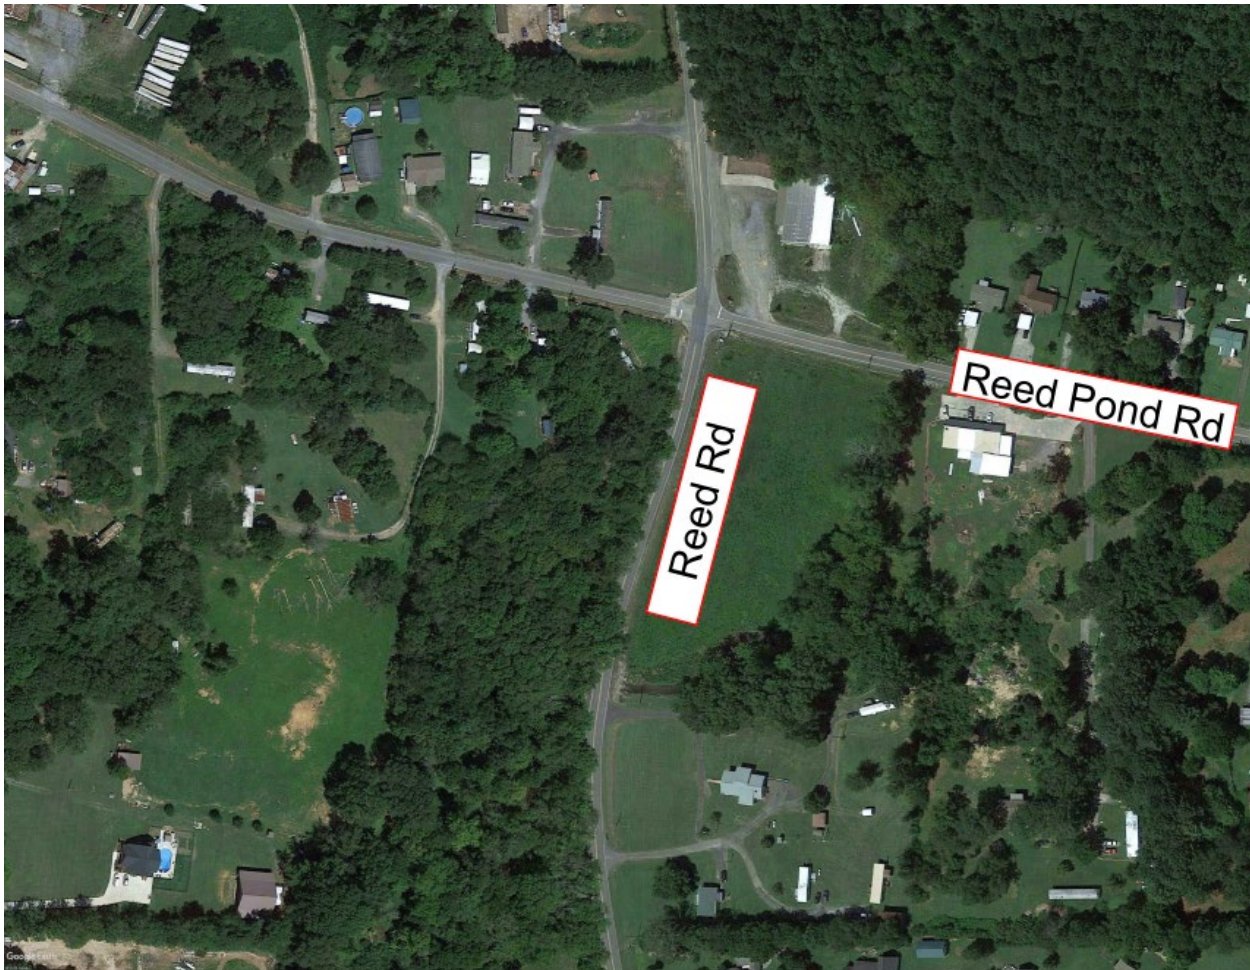
Figure 23: Intersection at Reed Road and Reed Pond Road

Reed Road is a two-lane facility with a posted speed limit of 45 miles per hour and classified as minor collector. Reed Pond Road is a two-lane facility classified as a local road and has a posted speed limit of 35 miles per hour. The study intersection is minor-street stop-controlled intersection and is located on a horizontal curve. The sight distance from the west approach is an issue at this intersection.

Fifteen crashes were observed at and near this intersection, out of which eleven occurred in wet/rainy conditions. Due to the horizontal curve, not a collision with motor vehicle type crashes near the intersection was due to the departure of vehicles from the travel lane.

To reduce the departure of vehicles from the road, friction of the pavement could be increased, and drainage can be improved at the intersection. Other improvements include having rumble stripes on the roadway to alert the driver and enhance the visibility of lane markings during wet and night conditions. Improvements like enhanced delineation of the curve at the intersection using flashing beacons for the intersection and chevron signs for the curve. **Figure 23** shows an aerial view of the intersection location.

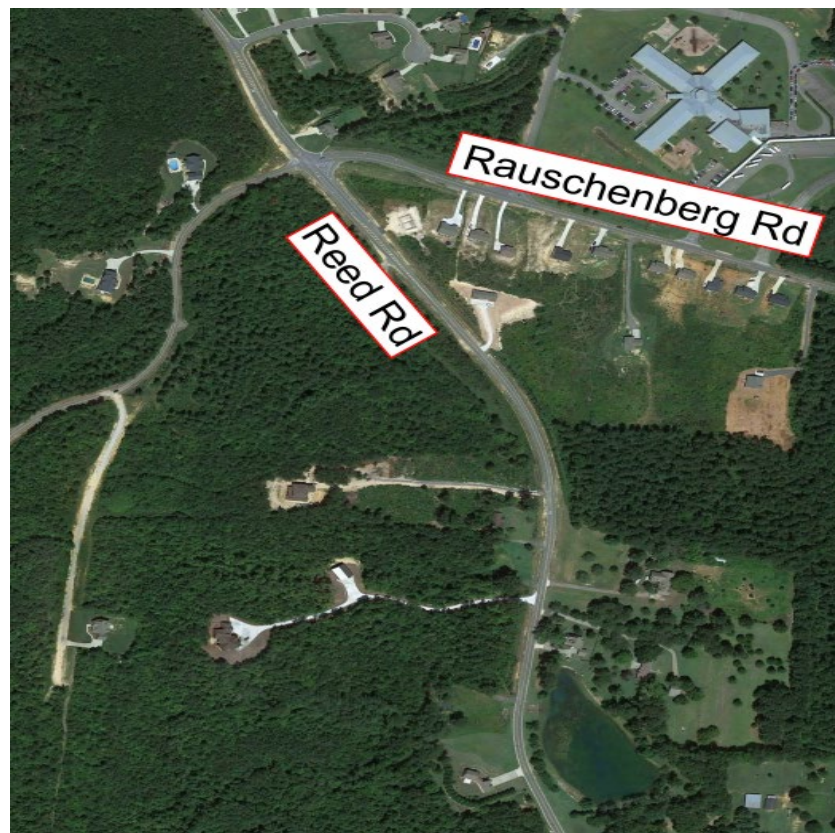
Figure 24: Reed Road and Rauschenberg Road

The intersection is a minor-street stop-controlled, 4-legged intersection. Rauschenberg Road is a local two-lane facility road with a posted speed limit of 35 miles per hour. Reed Road is a two-lane facility with a posted speed limit of 45 miles per hour and classified as minor collector. The geometric issues observed at this intersection were limited sight distance for the vehicles trying to make a through or left turn out of Rauschenberg Road. The intersection is located on a downhill slope and near a vertical curve crest.

Fourteen collisions were reported on this intersection, including four injury crashes. Six crashes at the intersection were angle crashes involving vehicles trying to exit out of Rauschenberg Road. Another major issue was the sideswipe crashes in wet conditions.

Two fatal crashes were reported to the south of the intersection on a horizontal curve. As the curve is located on a downhill slope, speed studies should be conducted to help understand the reasons for those deadly crashes. Low-cost improvements that can be installed to reduce the hazards on the intersection and curve are increasing delineation by chevron signs for curve and flashing beacon at the intersection. Increasing the pavement friction or adding clear zones on the curve might reduce the crashes. Another solution is to install rumble stripes to alert the driver as well as improve the visibility of pavement markings. **Figure 24** shows an aerial view of the intersection location and curve.

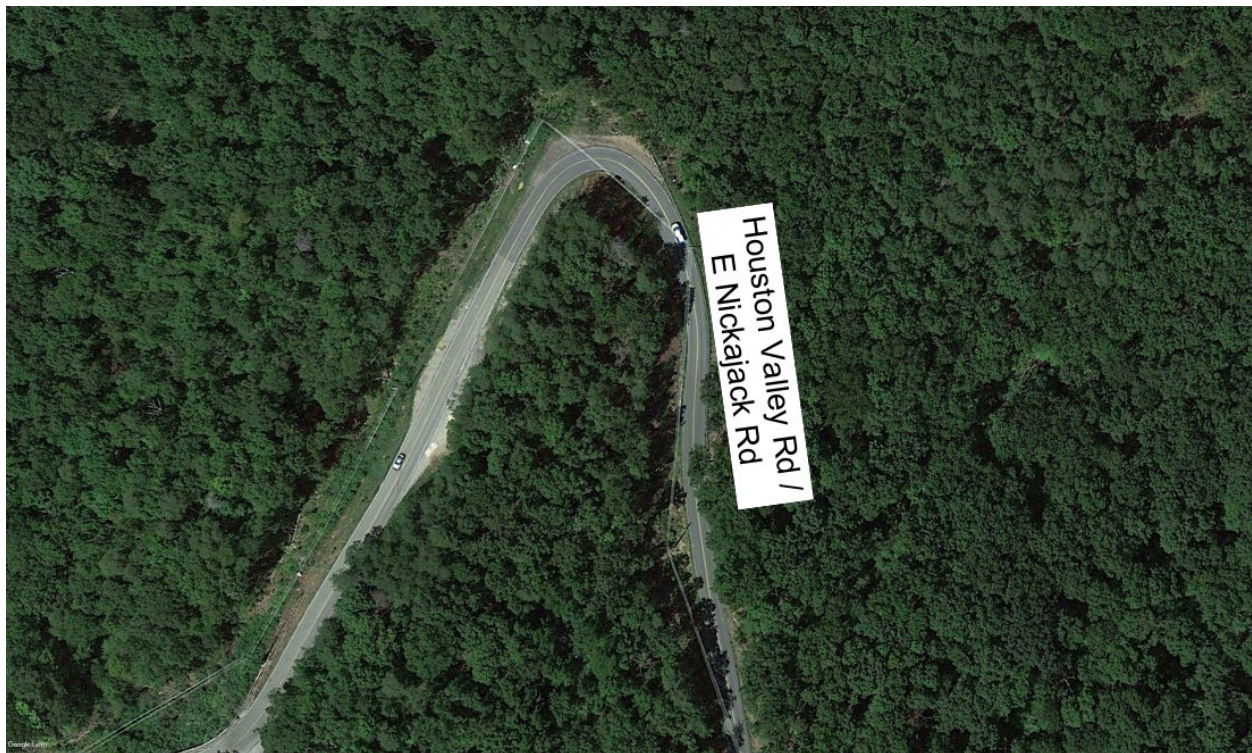
Figure 27: Houston Valley Road/East Nickajack Road

The crash site is located at the county border of Whitfield and Catoosa counties. The site is on Houston Valley Road / East Nickajack Road, which is a local two-lane facility road with a posted speed limit of 35 miles per hour. The crash site is on an uphill slope with a sharp horizontal curve.

There were 20 accidents on the crash site. The types of crashes were angle, sideswipe-opposite direction, head-on, and not a collision with a motor vehicle. Low-cost improvements to reduce crashes include enhanced delineation of the curve with chevron signs. Installing rumble stripes and providing clear zones at the curve will help reduce the number of crashes. Most of the crashes occurred in wet conditions. Drainage issues, if any, should be fixed or pavement friction should be increased. Wider lanes with proper embankment should also help reduce the number of crashes. The crash site location is as shown in **Figure 27**.
